# NOTICE TO MARINERS

## DOGGER BANK OFFSHORE WIND FARM

| NOTICE TO MARINER NUMBER | LF600013-ESI-DOG-NOT-0012 Rev01 |

### Dogger Bank B Export Cable Reduction to Charted Depth

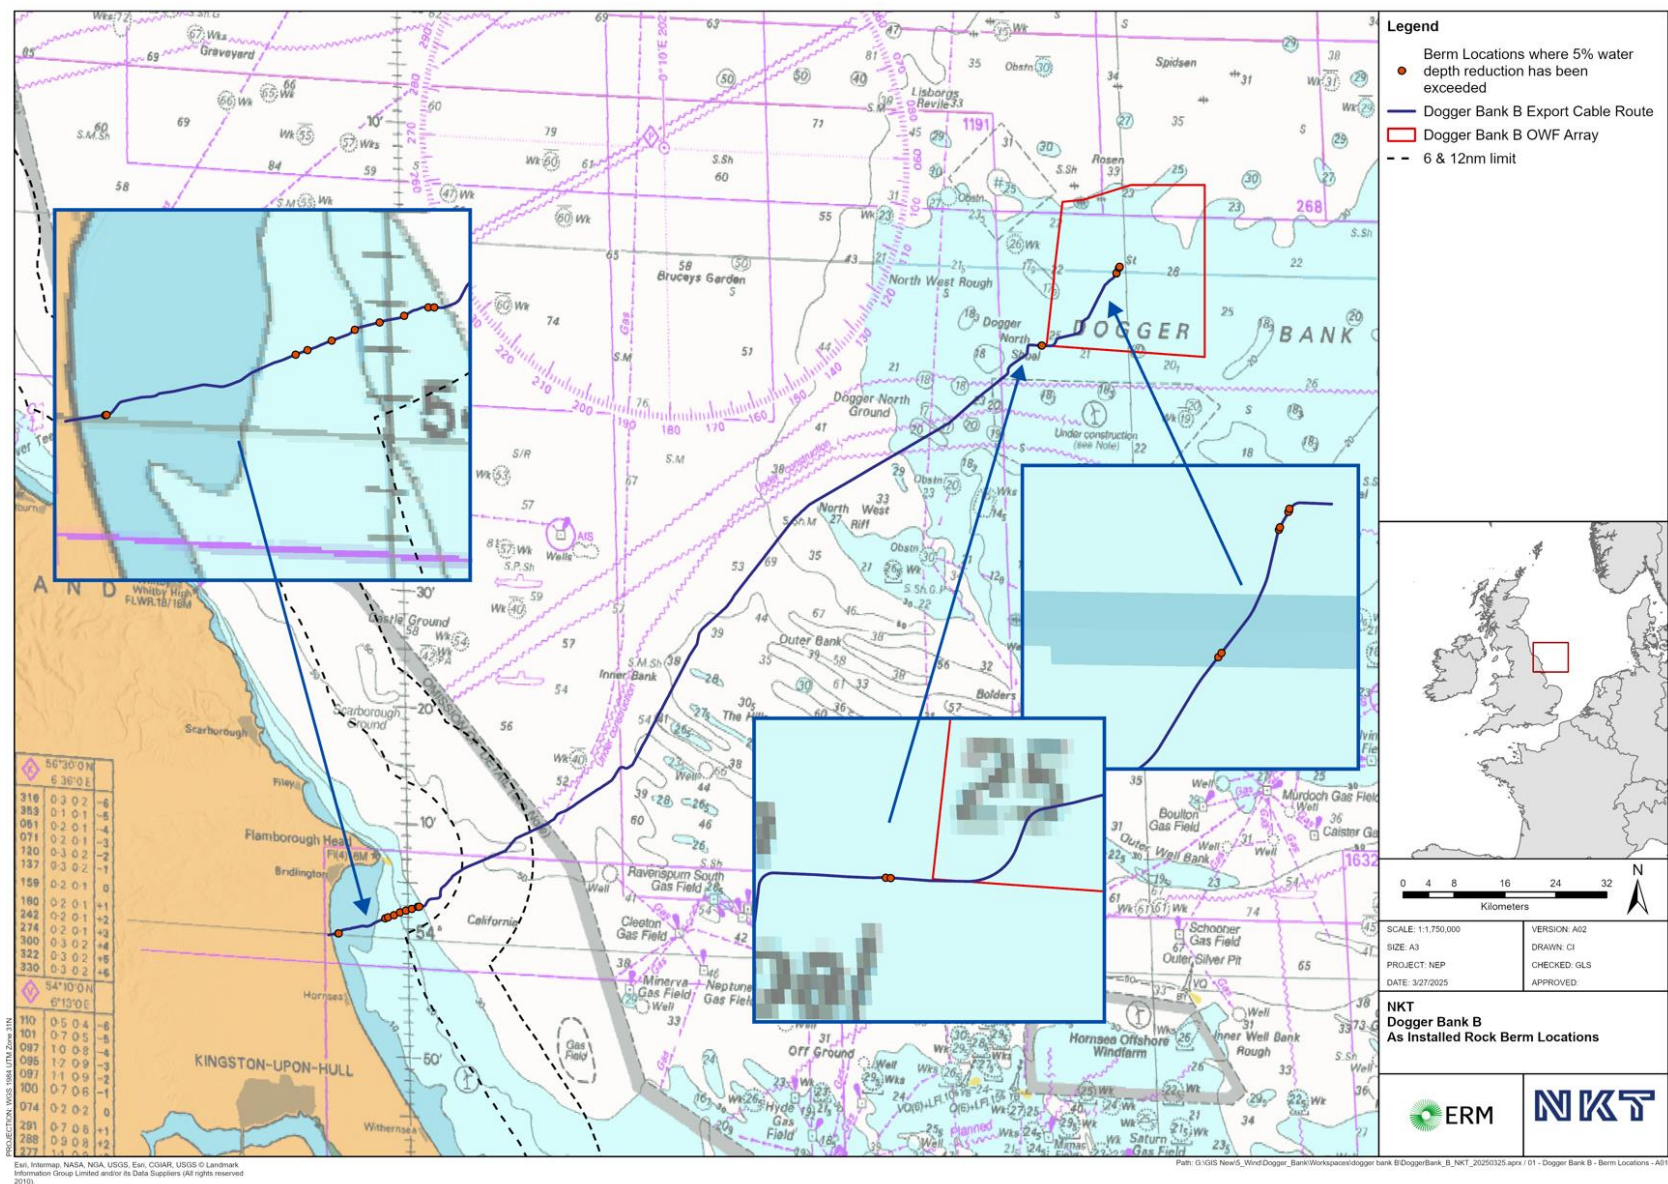
**Figure 1:** DBB Export cable water level reduction locations

The sections of cable where the reduction in water depth has exceeded 5% are shown in Figure 1. Table 1 presents a summary of the maximum or worst case depth changes as a result of the as-installed rock berms within each section and Table 2 presents the locations of each section where the water depth has exceeded 5%.
