# NOTICE TO MARINERS

## DOGGER BANK WIND FARM

| NOTICE TO MARINER NUMBER | LF600013-ESI-DOG-NOT-0012 |

### Dogger Bank C Export Cable Reduction to Charted Depth

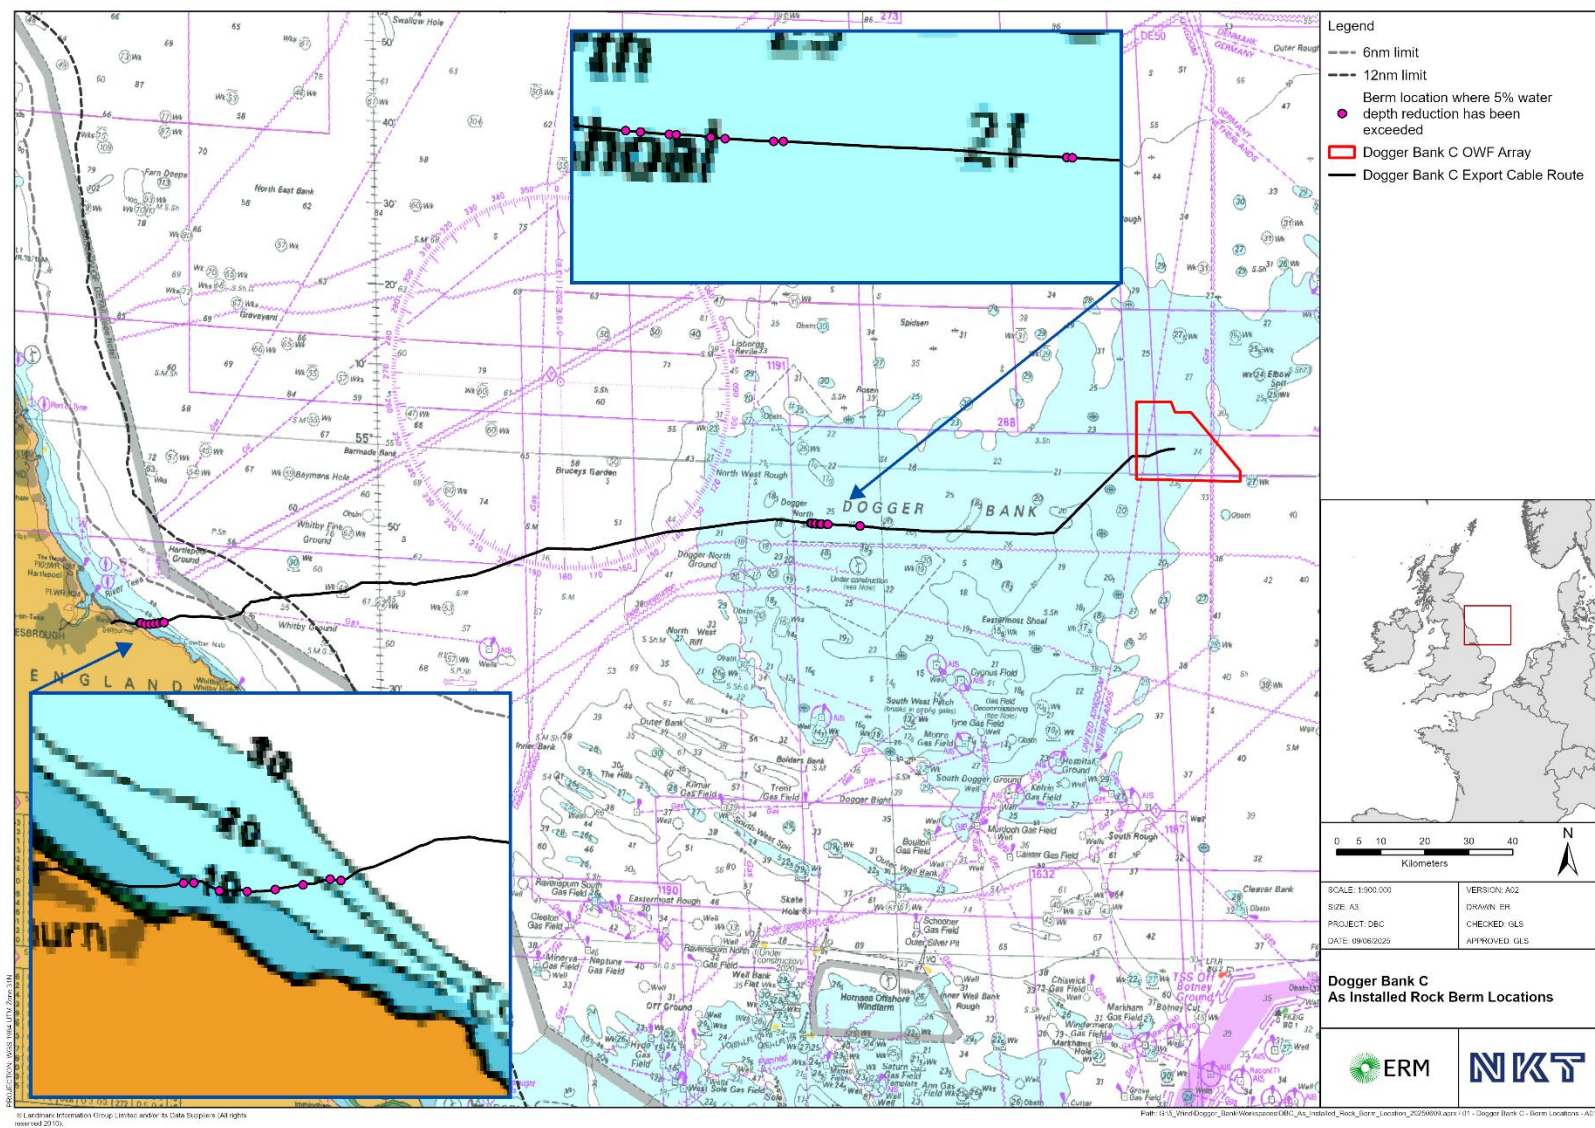
**Figure 1:** DBC Export cable water level reduction locations

The sections of cable where the reduction in water depth has exceeded 5% are shown in Figure 1. Table 1 presents a summary of the maximum or worst-case depth changes as a result of the as-installed rock berms within each section and Table 2 presents the locations of each section where the water depth has exceeded 5%.
