Dogger Bank C/Sofia Onshore Works Application

Appendix 4 – Annex A

Ecology Survey Report 2020

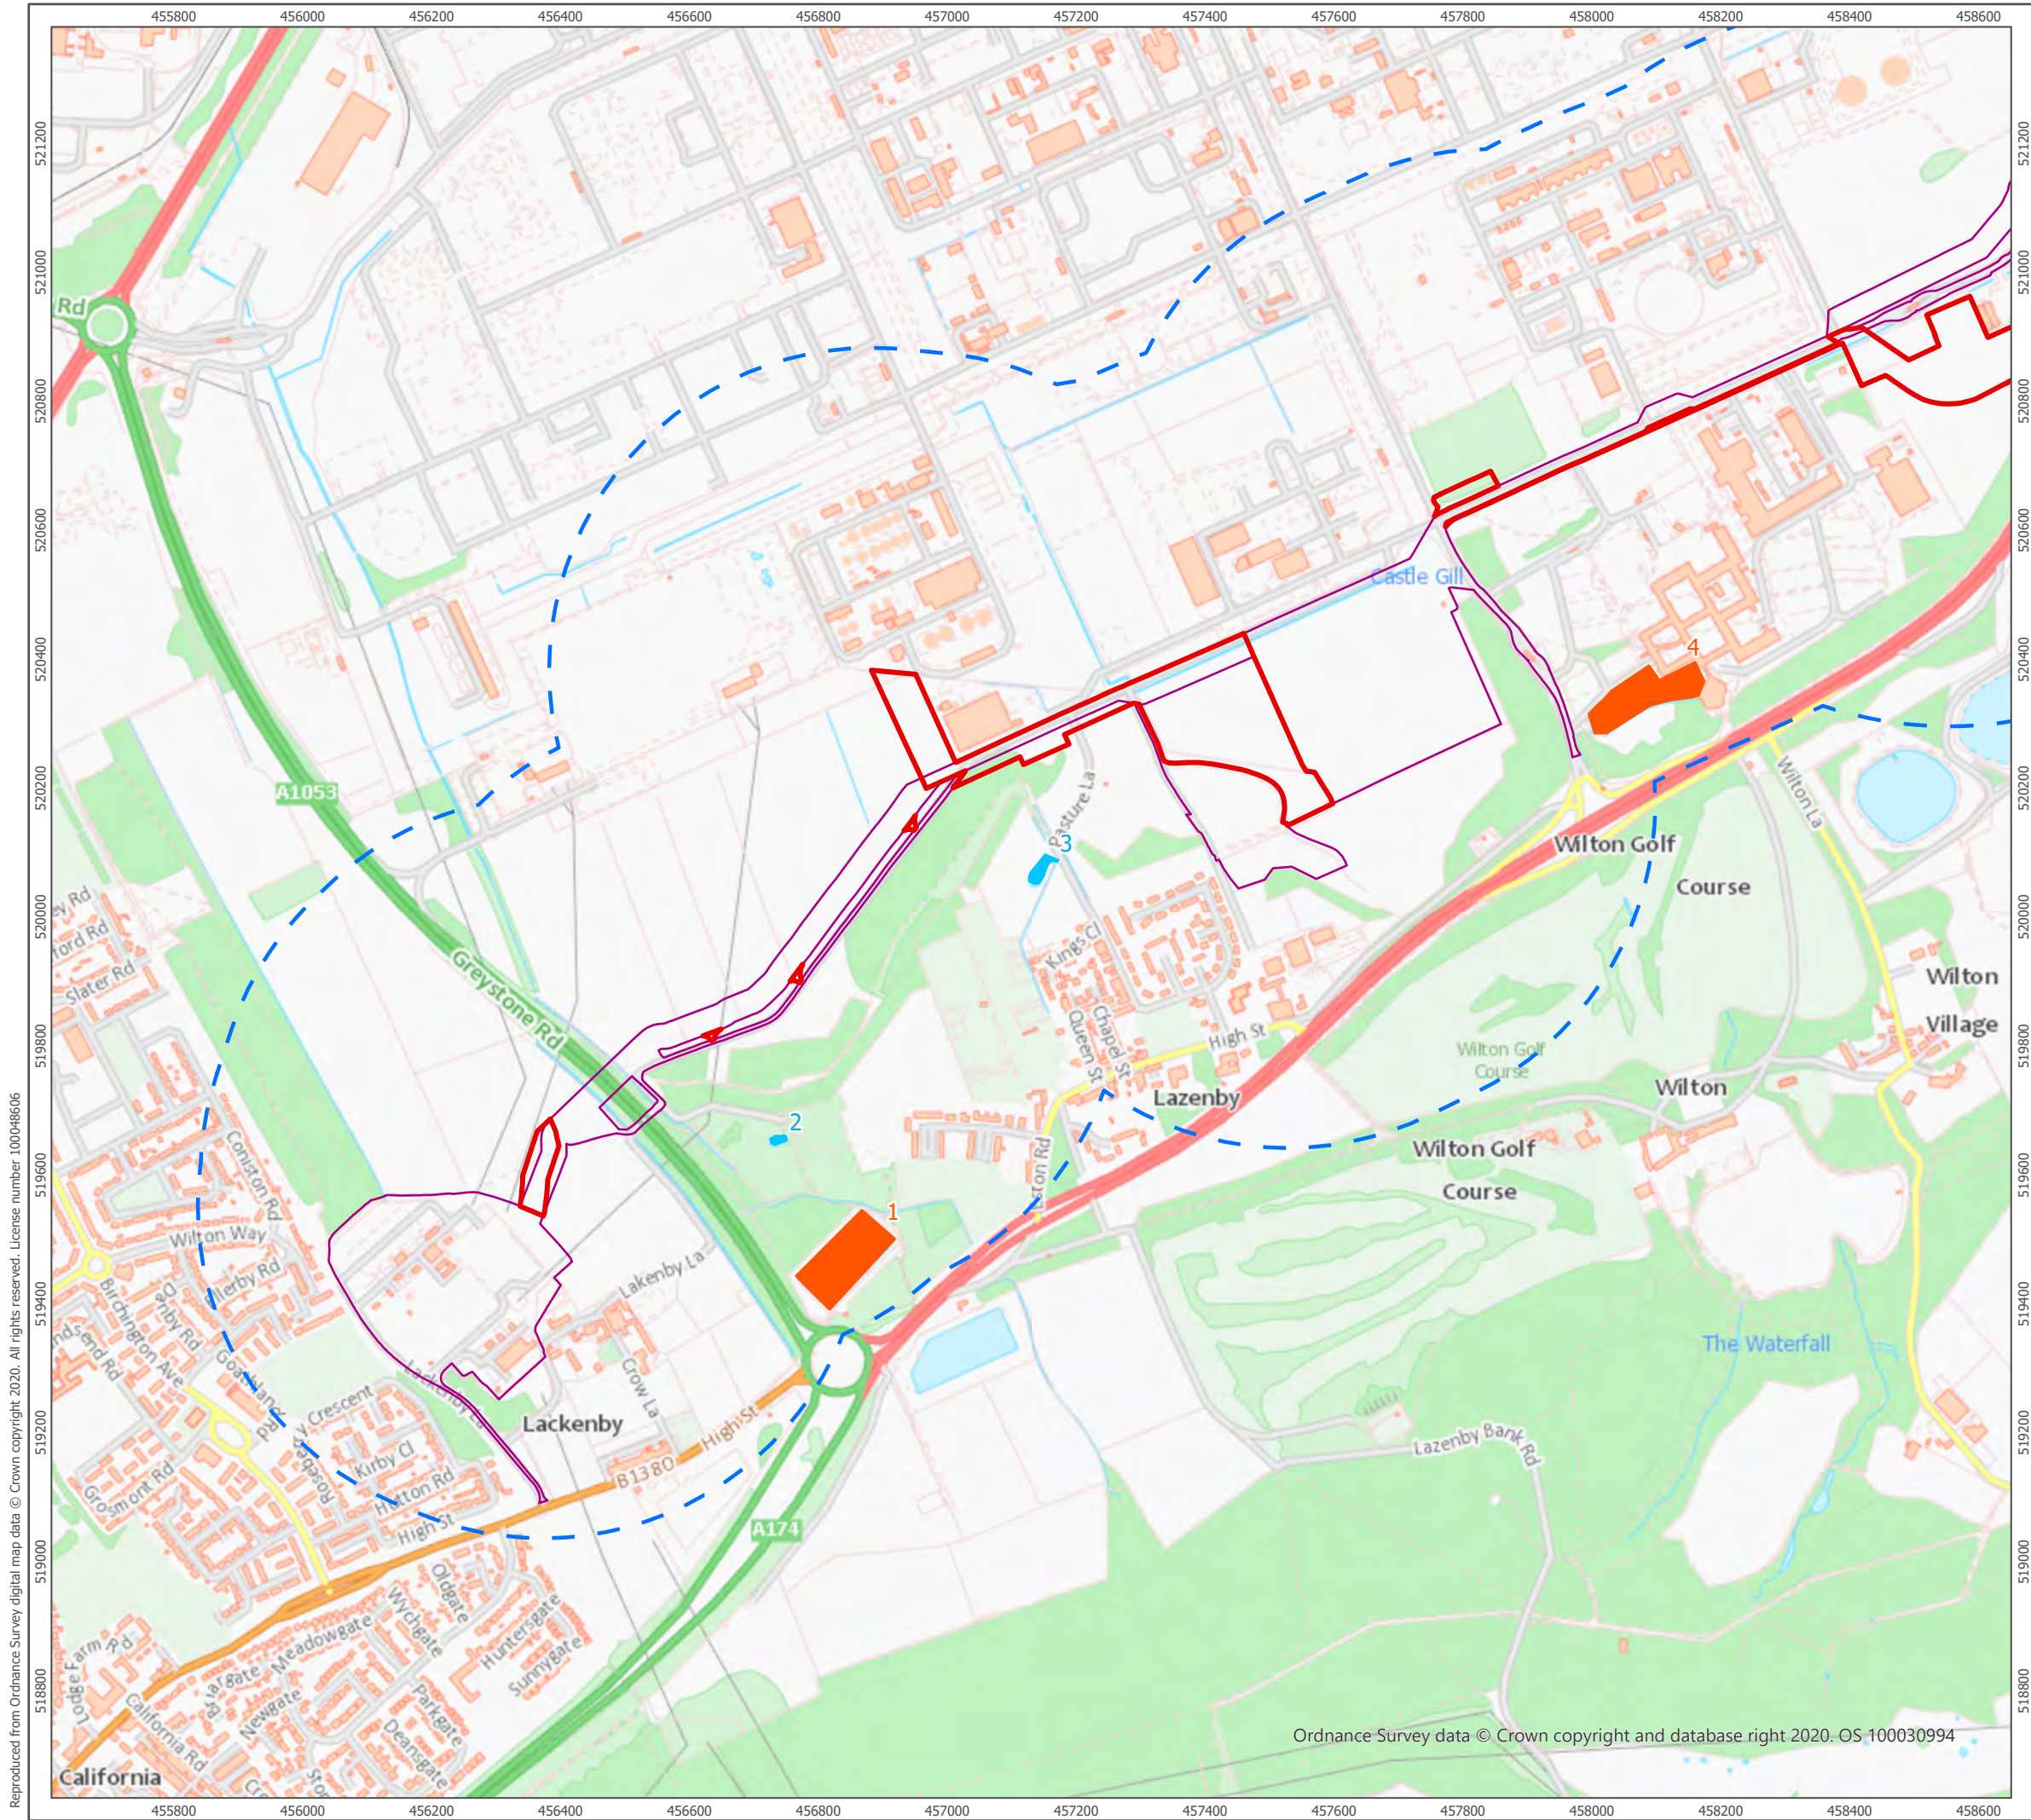
GCN Survey Area and Results 1
(2020)
Figure 3.4

- Planning Application Boundary
- DCO Limits
- GCN Survey Area (500 m Buffer of Planning Boundary)
- Survey Complete- GCN Absent
- Scoped Out (Low HSI)

Water bodies within 500 m of the Works were identified from OS maps and subject to an initial Habitat Suitability Index⁹ (HSI) assessment (Figures 3.4 to 3.6). Of the 21 ponds subject to HSI assessment, nine were subject to further detailed presence/absence surveys in accordance with guidance^{10,11} and under licence from Natural England.

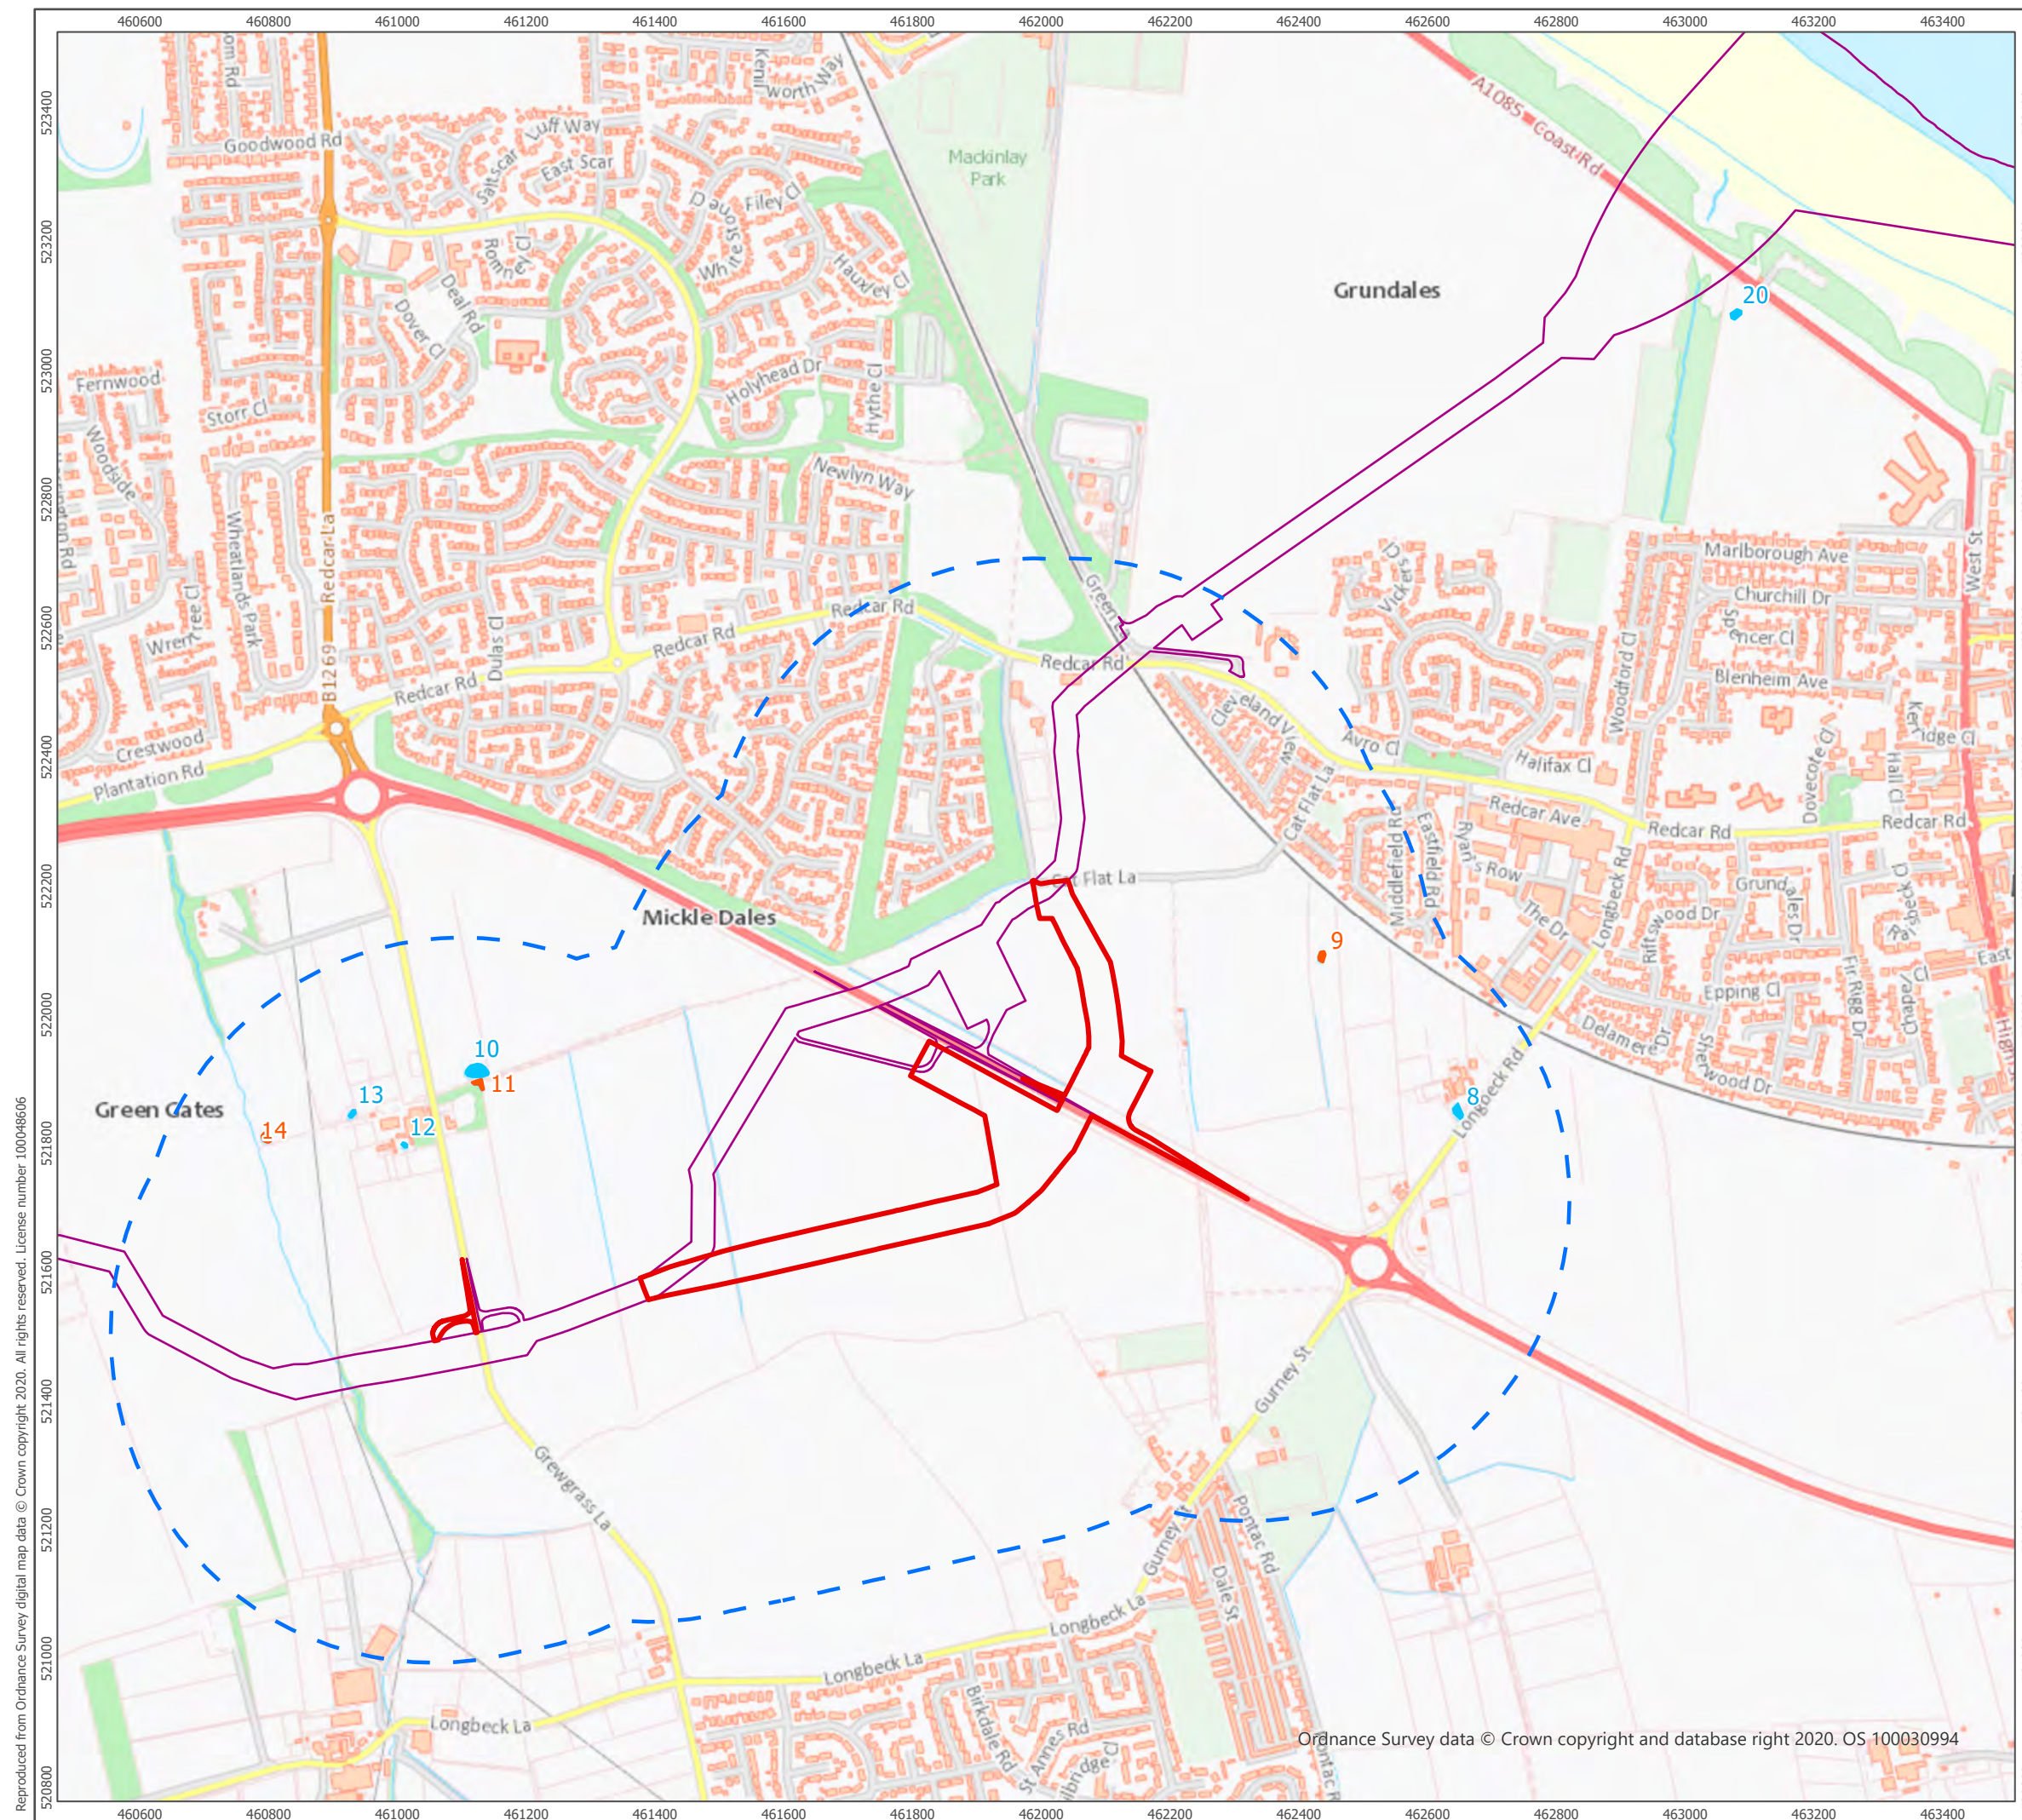
**GCN Survey Area and Results 2
(2020)**
Figure 3.5

Planning Application Boundary
-

DCO Limits
-

GCN Survey Area (500 m Buffer of Planning Boundary)
-

Survey Complete- GCN Absent
-

Scoped Out (Low HSI)

Pond 19 (Figure 3.5) was not accessible at the time of survey due to its location within a secure area of Wilton International. Pond 19 achieved an average HSI score (when viewed from behind metal security fencing with binoculars) which would ordinarily necessitate further survey; however, further survey was not possible. Pond 19 lies 350 m north of the Works, separated by suboptimal terrestrial habitat comprising bare ground, short grassland and a series of fences. Due to these factors and the absence of GCN from all ponds within 500 m of the Works, the lack of access at Pond 19 is not considered to be a significant limitation to the assessment.

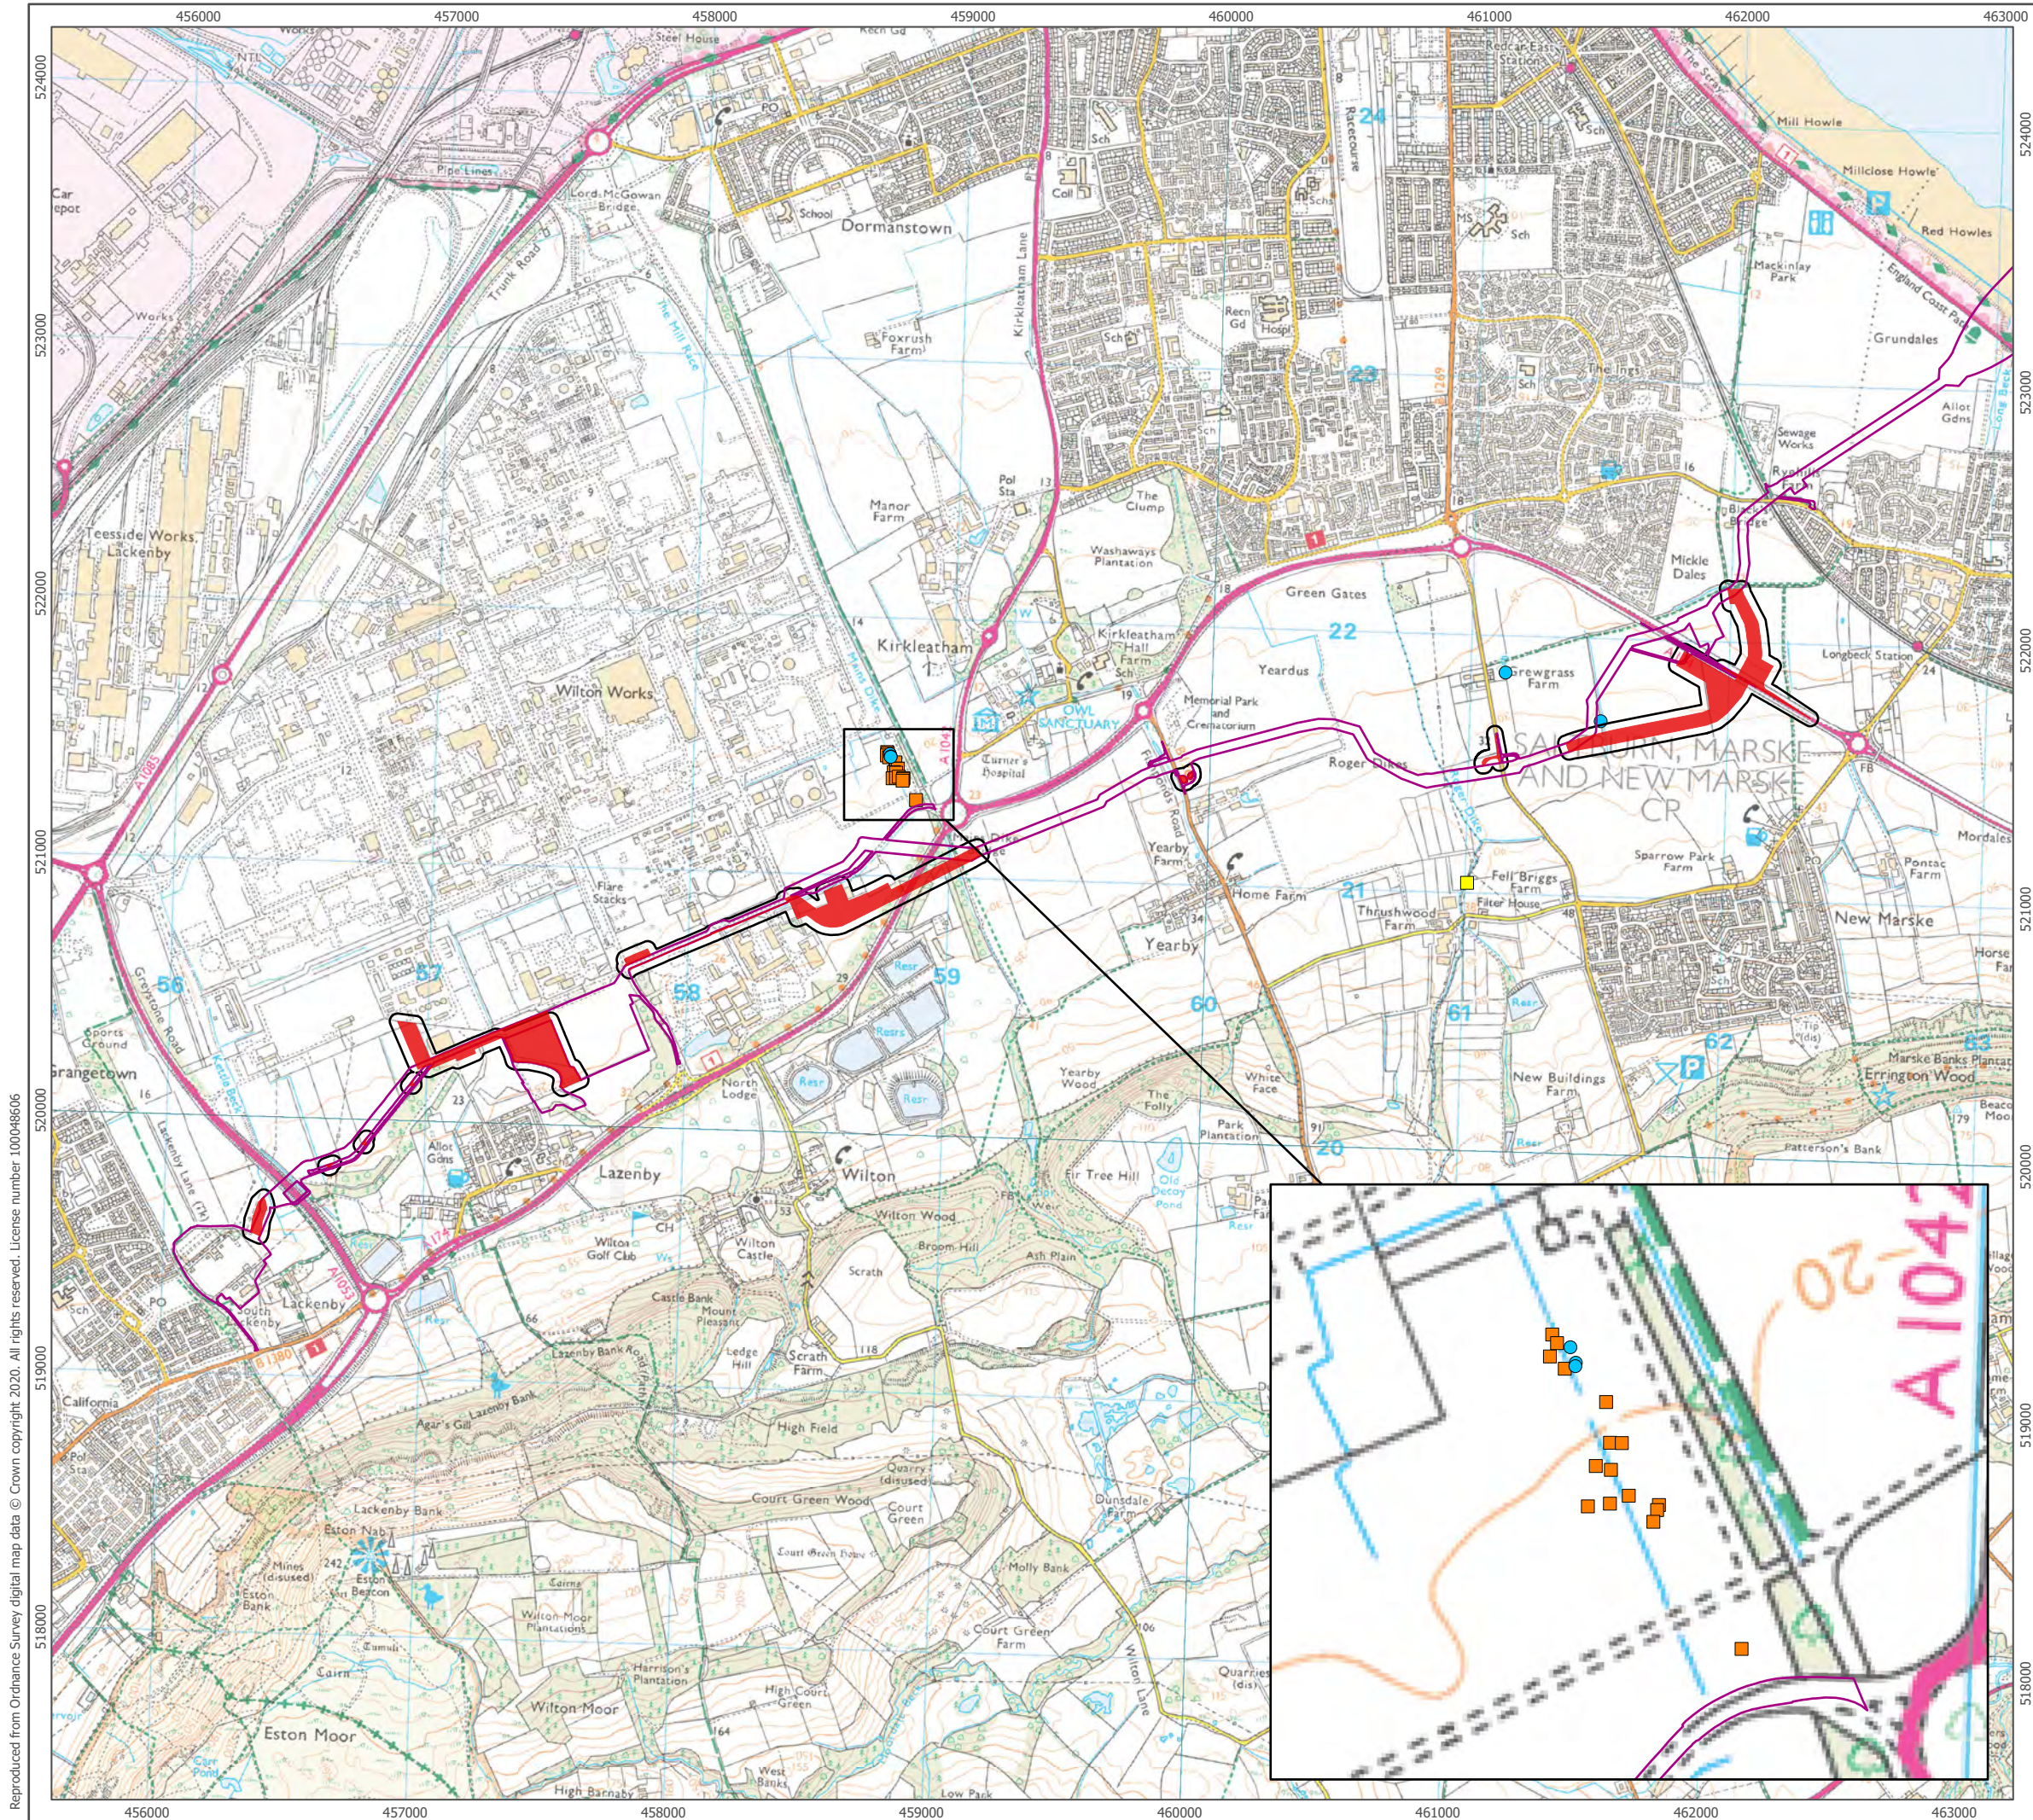
Badger Survey Area And Findings (2020)
Figure 3.8

- Planning Application Boundary
- DCO Limits
- Planning Boundary Badger Survey Area (30 m Buffer)
- Disused badger sett entrance (identified in 2020 Surveys)
- Badger Sett Entrance (identified during DCO surveys, no longer active in 2020)
- Badger sett entrance (identified in DCO surveys but not re-assessed in 2020 due to location)

Evidence of badger was sought during the Extended Phase 1 Habitat Survey, including revisiting setts identified in the 2014 ES. The survey included all areas within 30 m of the Works (Figure 3.8).
