NOTICE TO MARINERS

DOGGER BANK OFFSHORE WIND FARM

DATE OF ISSUE:	**07/11/2026**
NOTICE TO MARINER NUMBER	**LF500013-CST-DOG-NOT-0014 Rev 007**

Dogger Bank A, B, C Navigation Warning Boundary Buoy

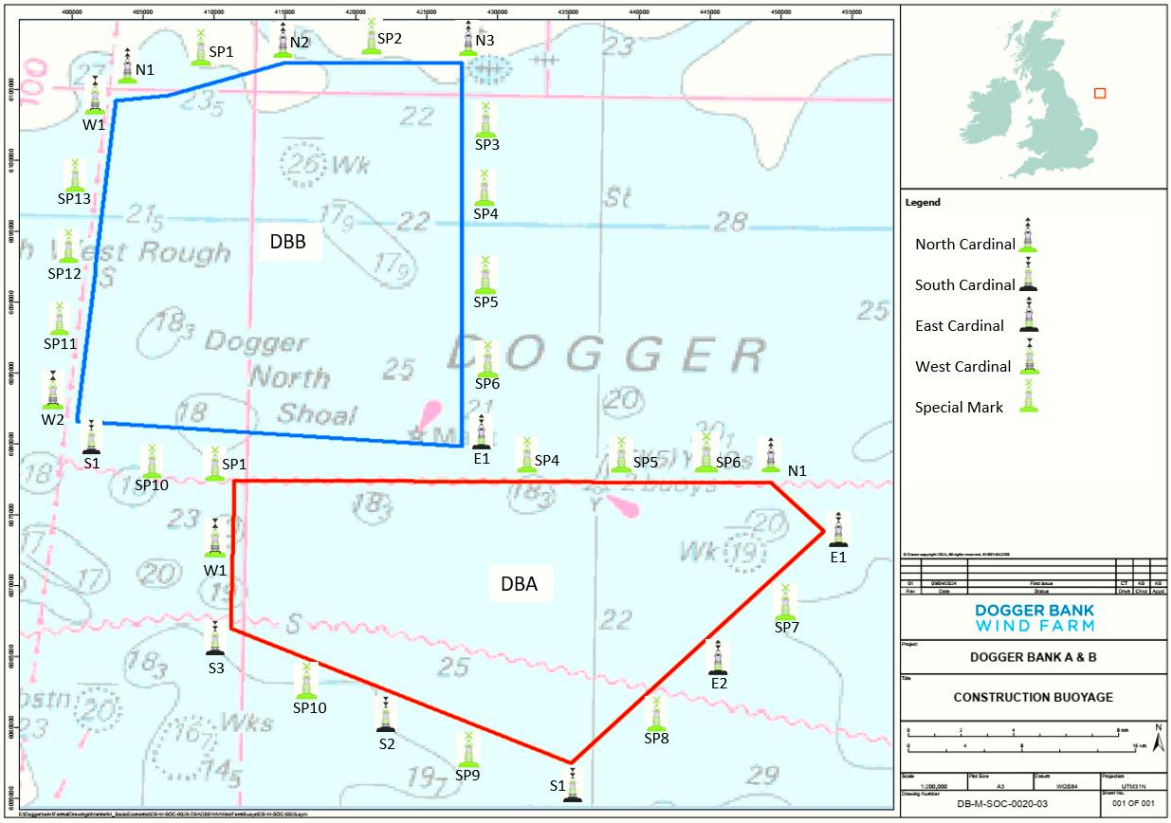
Figure 1: DBA and DBB Boundary Buoyage locations

Aid To Navigation	Position	Aid Type	Defect
DOGA Foxtrot (SP6)	54° 50.612' N 002° 04.734' E	Special Mark	Unlit Topmark missing Daymark missing
DOGB East (E1)	54° 52.116' N 001° 52.166' E	East Cardinal	Topmark missing
DOGB North (N2	55° 06.289' N 001° 40.488' E	North Cardinal	Unlit
DOGC S1	54° 57.020' N 002° 57.366' E	South Cardinal	Topmark missing

Rectification of the listed defects will be notified to mariners on completion.
